# Successful Office Building Window Upgrade Using Commercial Secondary Windows

Case Study of Pacific Tower at 915 Broadway, Vancouver

## The Project: 915 Broadway, Vancouver WA

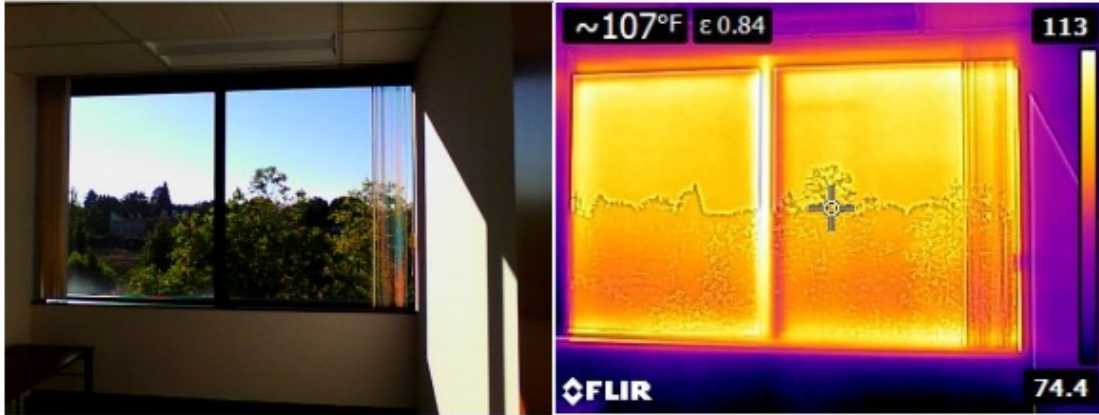
FIGURE 3 – THERMAL IMAGE OF PRE-INSTALL SE (SUNNY SIDE) GLAZING INTERIOR (9/2/20 8AM – OAT=63 °F)

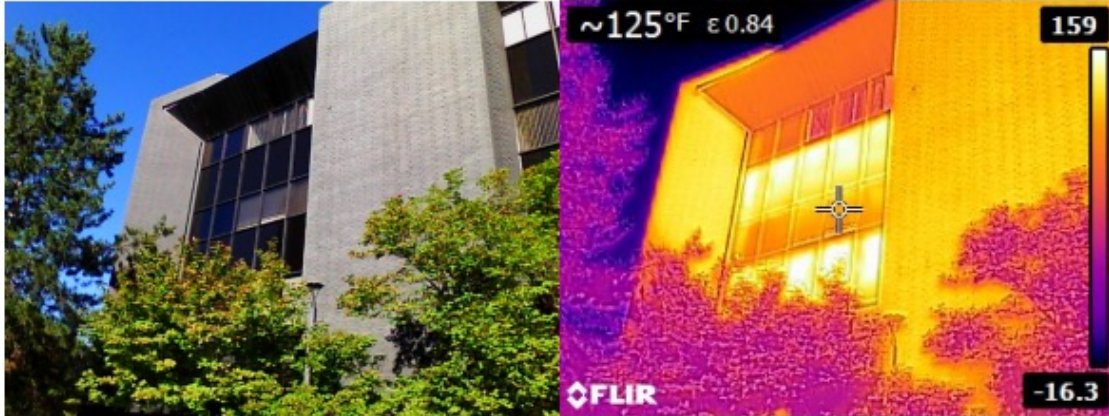
FIGURE 4 – THERMAL IMAGE OF PRE-INSTALL SE (SUNNY SIDE) GLAZING EXTERIOR (9/2/20 8AM – OAT=63 °F)

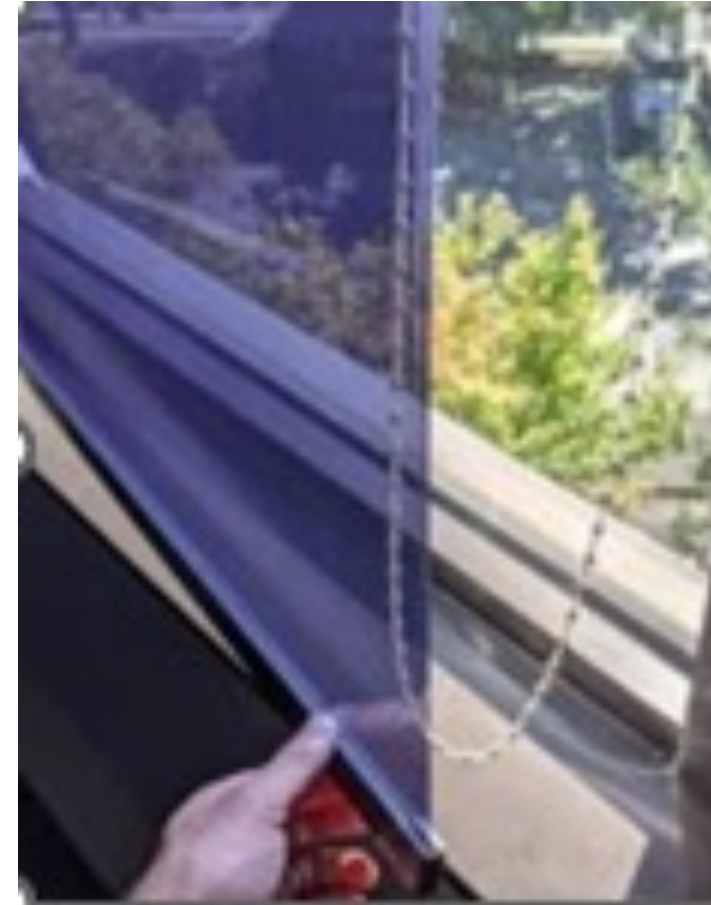
**Throughout the building, tenants used a variety of window treatments to manage heat gain as direct solar radiation on elevations caused unbearable discomfort during much of the year**

**HVAC system designed for 1975 conditions could not generate enough cooling for current changing climate**

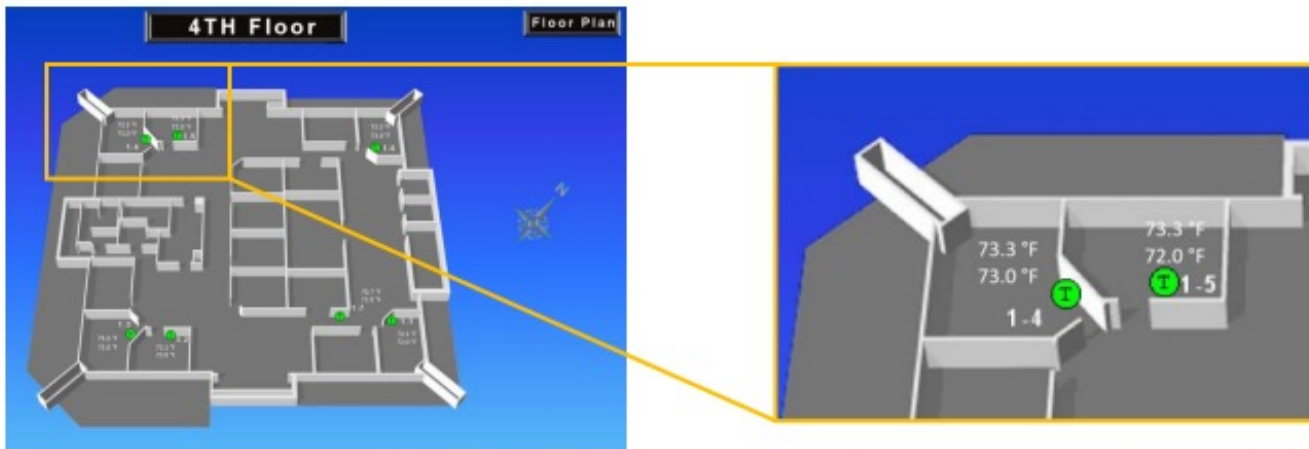
Temperature measurements from the 4<sup>th</sup> floor of 915 Broadway Street, taken on a record-breaking 115 °F day after the WinSert installation. Temperatures used to reach as high as 90 °F on 95 °– 100 °F days before the installation.

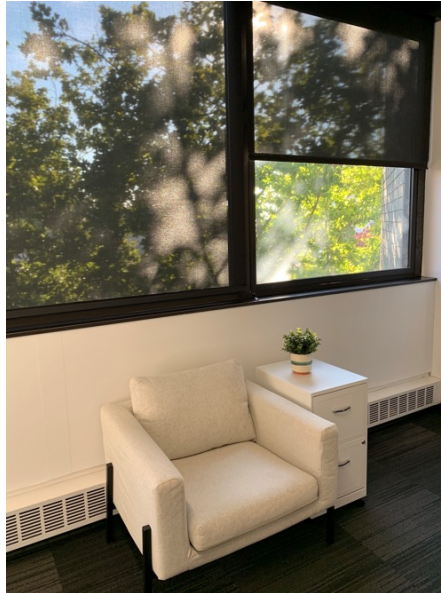
Before: Variety of “Bad” Shades
