# HARVEY MUDD COLLEGE CLINIC PROJECT – LEED BUILDING RECOMMISSIONING

*HT10SCE2100 Report*

*Design & Engineering Services  
Customer Service Business Unit  
Southern California Edison*

*December 8, 2011*

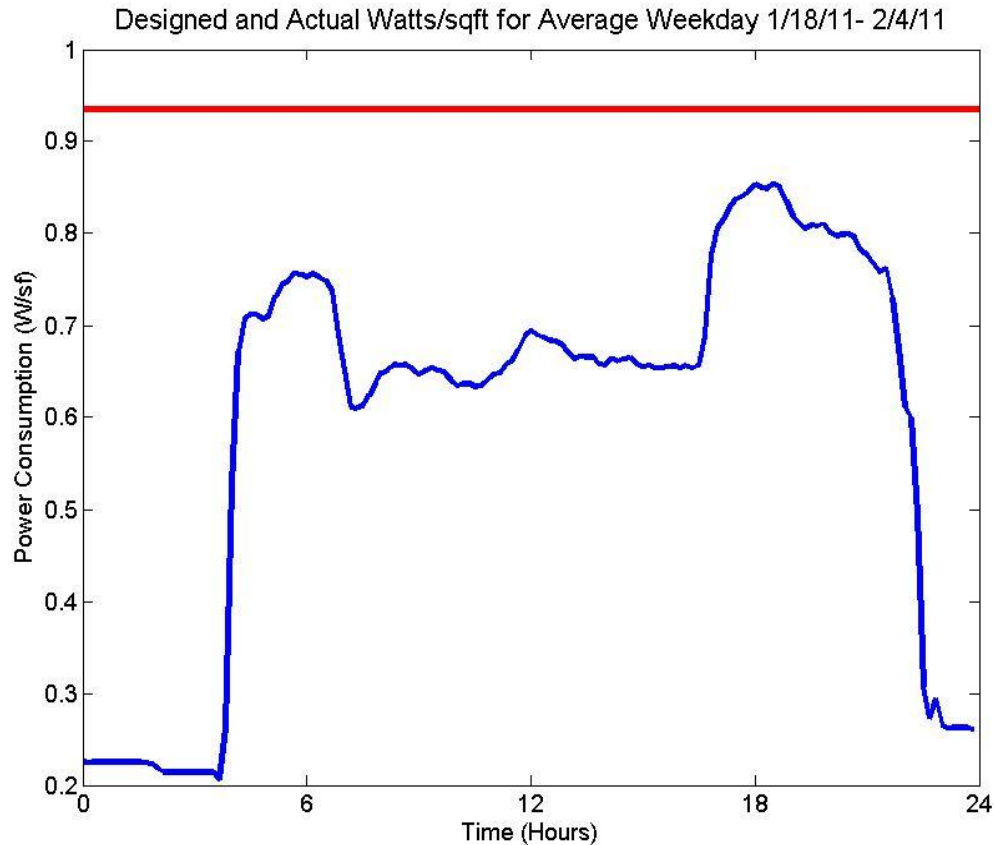
**FIGURE 7. DESIGNED AND ACTUAL LIGHTING WATTS/SF FOR AVERAGE WEEKDAY 1/18/11-2/4/11**

The power consumption data for the lighting panel was averaged over two weeks for weekdays and weekends. The weekend average power consumption values were normalized by the building’s square footage to obtain a plot of Watts/square foot (W/sf) consumed by the Hoch-Shanahan’s lighting system. Figure 7 shows the W/sf for the average weekday for January 18-February 4, 2011. The red line represents the designed watts/square foot value of 0.93 W/sf obtained from the original building energy model. As expected, the lighting system’s power consumption drops during the day, although the levels still remain within a fairly narrow range throughout the day. The drop can be attributed to a photosensor placed in the southwest atrium window. The drop in consumption is limited due to the relatively few numbers of lights in the atrium area controlled by the photosensor.

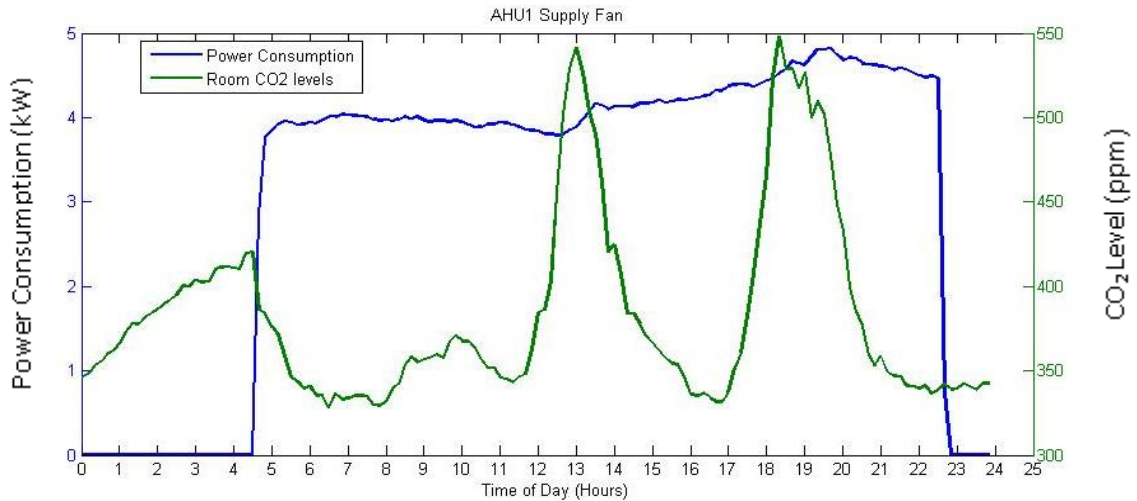
**FIGURE 9. POWER CONSUMPTION AND CO<sub>2</sub> LEVELS FOR WEST DINING AHU 1 SUPPLY FAN AVERAGED FROM 2/11/11 - 2/16/11**

A similar plot of the weekday average CO<sub>2</sub> levels and power consumption vs. time, shown in Figure 9, was obtained for the West Dining AHU 1 Supply Fan, which further reinforces those findings. An interesting feature of both plots is the relationship between the CO<sub>2</sub> levels and fan power consumption between 2:00 PM and 5:00 PM. Even though the CO<sub>2</sub> levels are constantly decreasing over this interval (due to a sharp reduction in building occupancy during this time between meals), the supply fan power consumption continues to increase. Given the time of day, this is likely a result of larger heat loads from rising ambient temperatures. Both Figure 8 and Figure 9 indicate that the control system is responding appropriately to the indoor CO<sub>2</sub> levels.

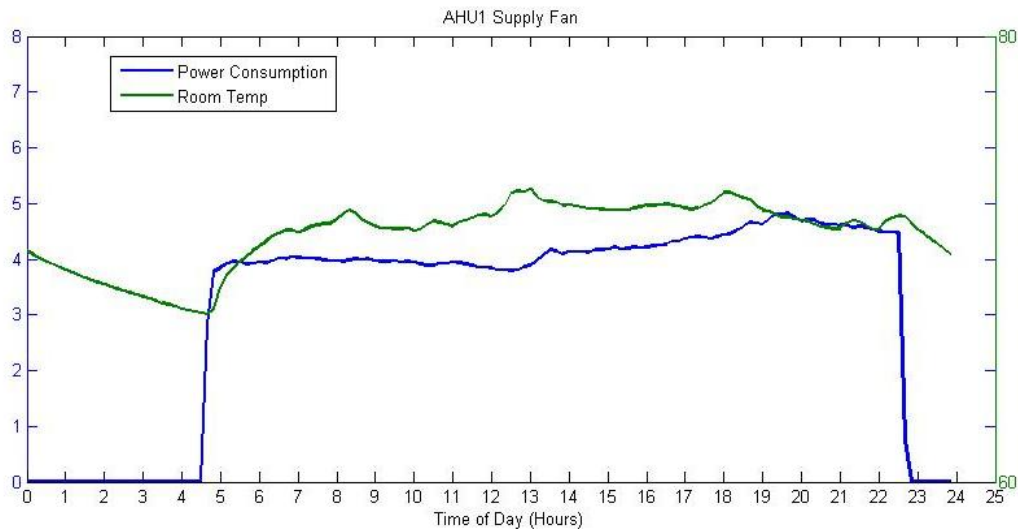
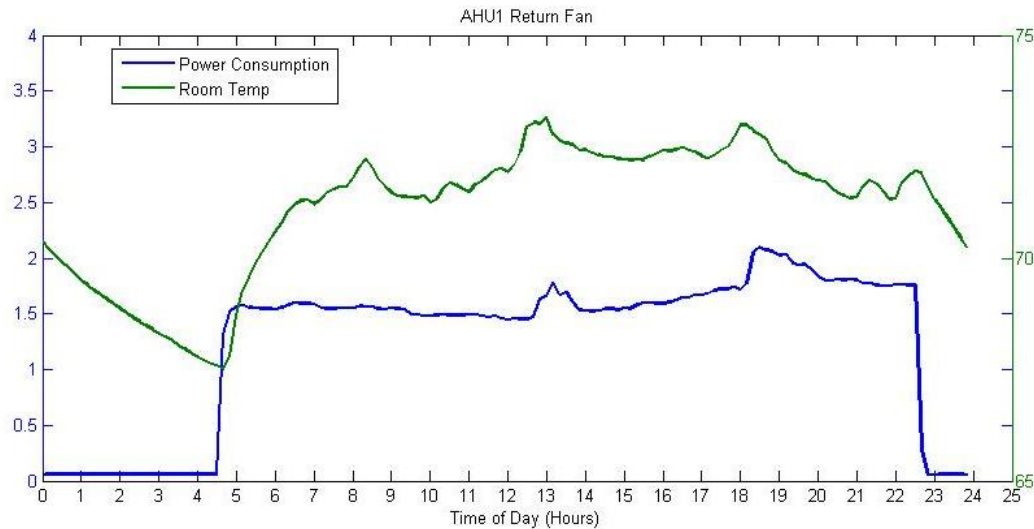
**FIGURE 10. ROOM TEMPERATURE AND POWER CONSUMPTION FOR WEST DINING AHU 1 SUPPLY FAN 2/11/11- 2/16/11**

To investigate further the performance of the control system, the team isolated and examined the HVAC system’s response to room temperature changes throughout the day. Similar analysis techniques were carried out to obtain room temperature data. This included pulling the room temperature readings from the control system applet and the AHU return and supply fan power consumption data from the Dranetz power monitors, and average those values over a period of weekdays and weekends to obtain general trends for the response of the HVAC system to temperature changes. Figure 10 and Figure 11 depicts the relationship the team found between the indoor temperature and AHU power consumption for the supply and return fans for the West Dining area.

From Figure 10 and Figure 11, it is clearly shown that both the supply and return fan for West Dining AHU 1 respond more to temperature than CO<sub>2</sub> levels. The power consumption characteristics observed here indicate that within the control system, the CO<sub>2</sub> levels affect the outside air dampers and the room temperature affects the fan speed. Examining the room temperature and fan power consumption data, we see that the system actually struggles to maintain the indoor temperature below the building's setpoint of 73°F during the day. Although the building is usually able to maintain the temperature within the specified three degree range of the temperature sensors, the building was slow to respond to changes in heating and cooling modes. This can be fixed by tuning the control system to cool the supply air more by opening the chilled water valve.

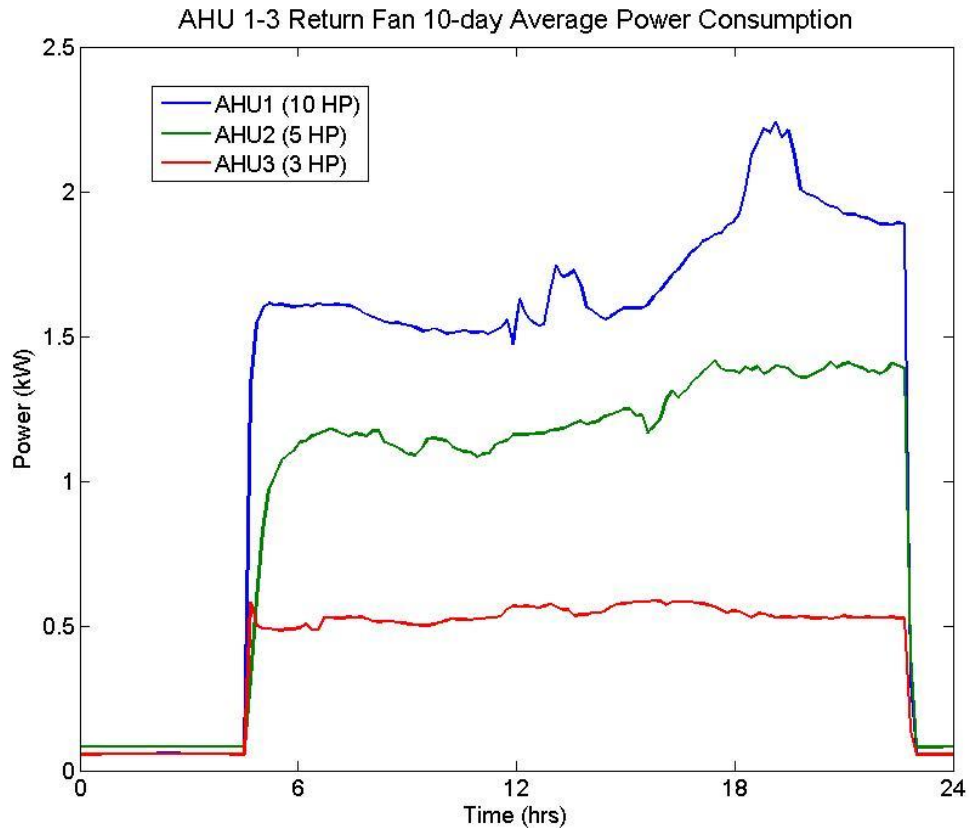
**FIGURE 12 . POWER CONSUMPTION FOR AHU 1-3 RETURN FANS AVERAGED OVER 10 WEEKDAYS**

The general shape of each dataset as well as the relative magnitudes of power usages for each return fan all align with the Clinic team's expectations. The general shape of each curve has an upward trend throughout the day, indicating heavier demand on the return fans in the later portions of the day as temperatures rise and building use increases from its minimum value during the night and early morning. The peaks in power consumption for West Dining AHU 1 return fan line up roughly with lunch and dinner, which is anticipated due to the West Dining area being the most heavily occupied during those times.

Additionally, the difference in power consumption between each return fan generally aligns with the indicated horsepower (HP) ratings for each fan motor, with AHU 1's 10 HP motor consuming the most power at any given time of day. To examine if the supply fans for the HVAC system were following similar trends, the team averaged power consumption data for AHU 1-5 supply fans over the same ten days as in Figure 12. The resulting plot is show in Figure 13.

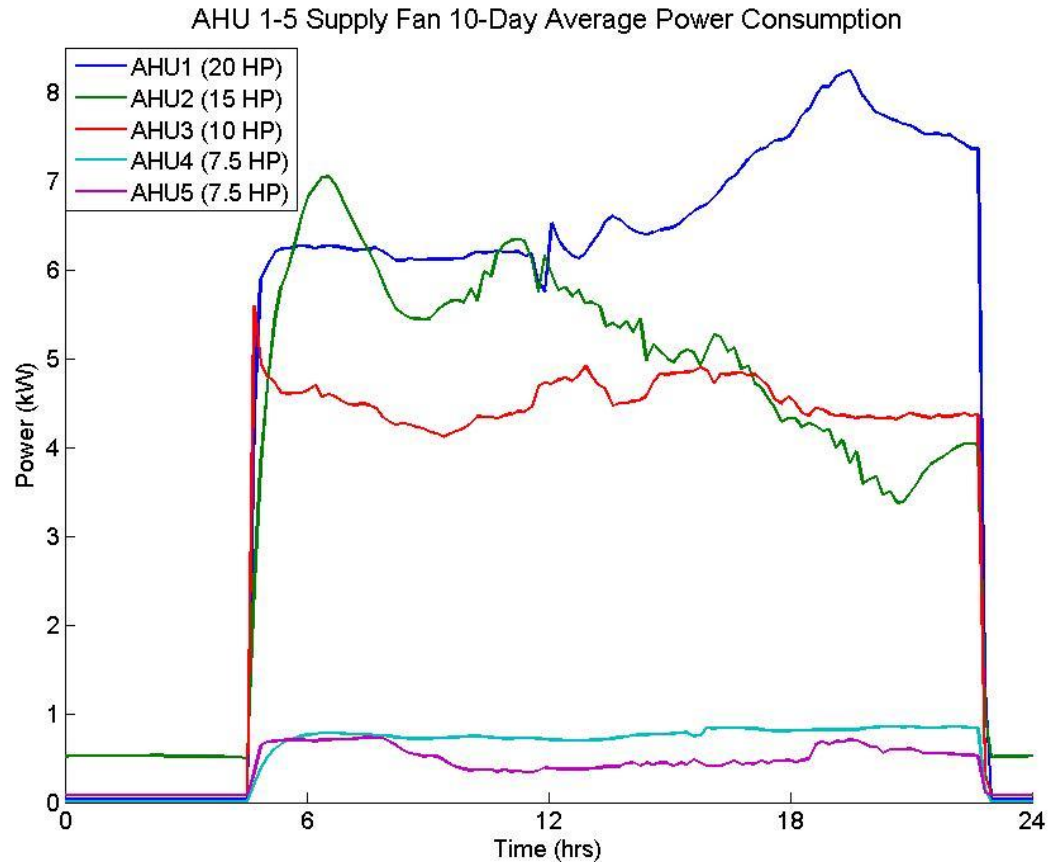
**FIGURE 13. POWER CONSUMPTION FOR AHU 1-5 SUPPLY FANS AVERAGED OVER 10 DAYS**

As shown, the Dining Atrium Supply Fan AHU 2 follows a different trend than the other supply fans. The fan did not match with the expected shape from the return fan in Figure 12 or the relative power usage amplitude anticipated from the fan motors power rating. The added anomaly of a downward trend throughout the day indicated that the team should further examine the data for each of the ten days from which the data was averaged. Figure 14 represents the power consumption from February 11-23 for the AHU 2 Supply Fan. The team found unexpected jumps in power consumption on certain days accompanied by an often erratic downward sloping curve profile. This showcases the characteristics of the AHU 2 Supply Fan data that contributed to both the increased magnitude and downward slope on the ten-day averaged plot in Figure 13. There was a sudden jump in maximum daily power consumption from approximately 3.75 kW to in excess of 10 kW around day 5, corresponding to February 16, 2011. The team initially suspected that some external factor, such as a short in the circuit somewhere or drastic change in weather from the previous days, was influencing the supply fan exclusively.

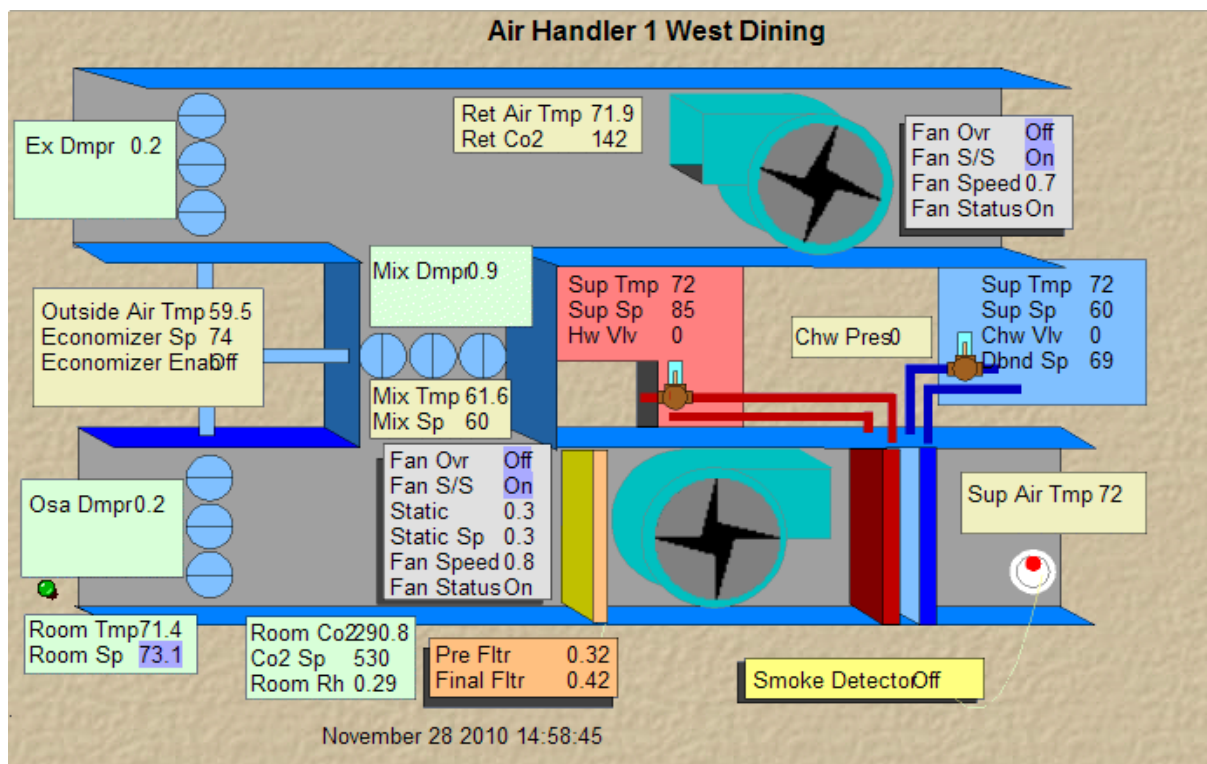
**FIGURE 17. CONTROL SOFTWARE INTERFACE**

The team had limited access to the software that controlled the HVAC system. Figure 17 shows an image of the software interface for the control system.

This Figure 17 screenshot is for the West Dining AHU 1. The return air from the dining hall is collected up using the return fan where the return air temperature and CO<sub>2</sub> levels are being measured. The exhaust damper, Ex Dmpr, determines how much air is exhausted out of the building and how much is recycled. The recycled air then mixes with a certain amount of outside air, which is determined by the outside air damper, OSA Dmpr. The mixed air is then heated or cooled and pushed back into the building by the supply fan. The amount of outside air is determined by the room CO<sub>2</sub> sensor, while both the supply fan speed and the hot and cold water valves are modulated by the room air temperature. This setup is identical for AHU 2.

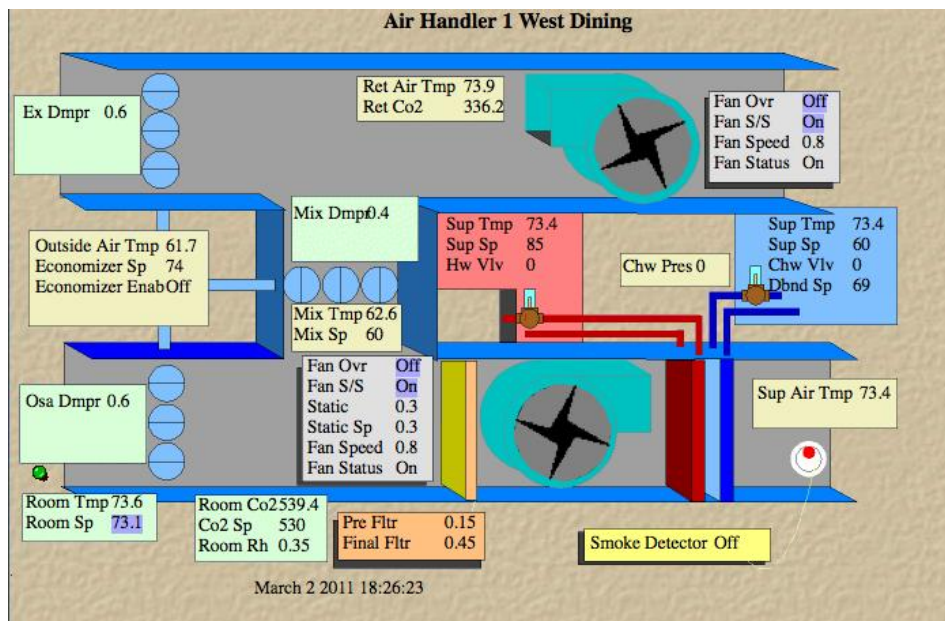
**FIGURE 18. WEST DINING AHU 1 CONTROL SYSTEM RESPONDING TO CO<sub>2</sub> LEVELS**

Here, in Figure 18, the CO<sub>2</sub> levels have just exceeded the setpoint. The Exhaust and Outside Air dampers opened from 0.2 to 0.6 to lower the CO<sub>2</sub> levels.

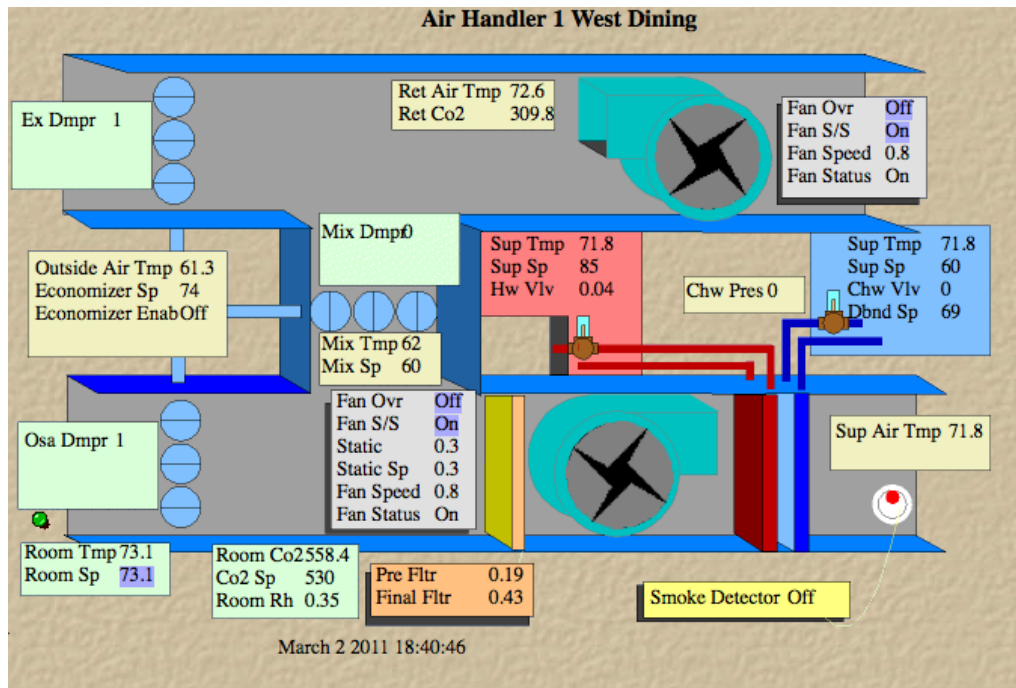
**FIGURE 19. WEST DINING AHU 1 CONTINUING TO RESPOND TO CO<sub>2</sub> LEVELS BY OPENING DAMPERS TO MAXIMUM POSITION**

As the CO<sub>2</sub> stays above the setpoint in Figure 19, the Exhaust and Outside Air dampers open all the way to allow for maximum outside air. Additionally, the hot water valve begins to open to heat the outside air to the desired supply air temperature.

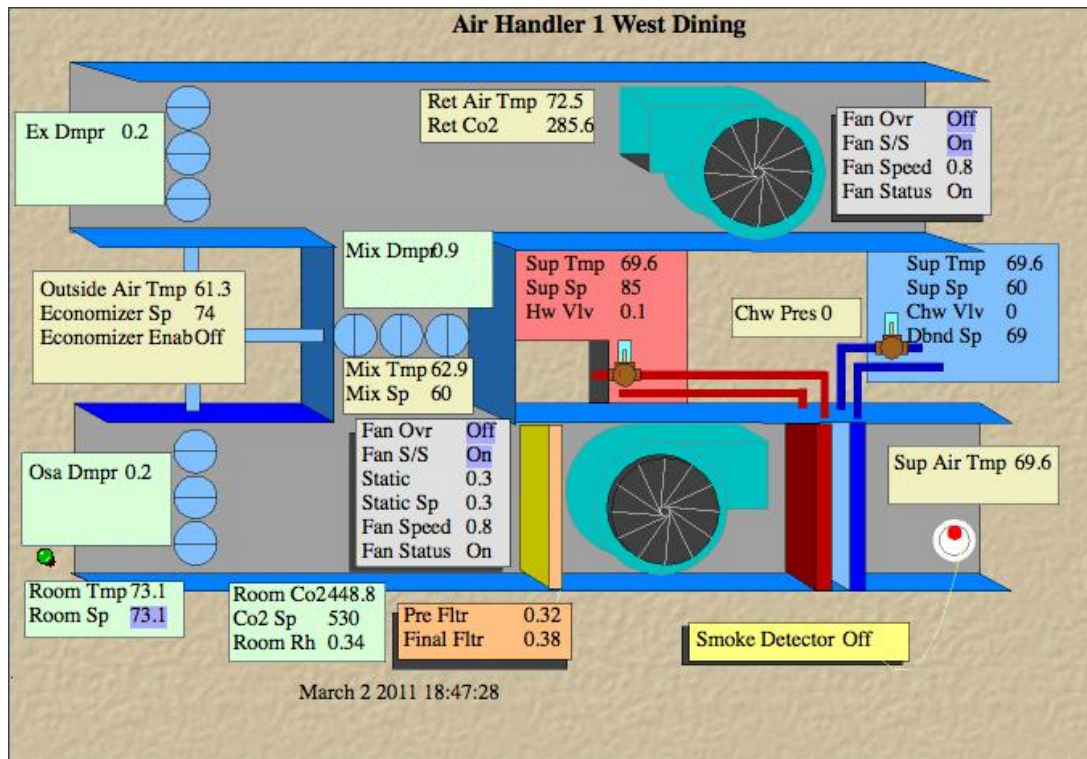
**FIGURE 20. WEST DINING AHU 1 RETURNING TO NORMAL OPERATION**

The CO<sub>2</sub> levels return to below the setpoint and the Osa and Ex dampers go back to the default of 0.2, shown in Figure 20. The heat is still working to maintain a constant supply air temp. Note, however, that the fan speeds remain constant throughout the process. It is also interesting to note that the fan speeds do not drop when the room temperature and CO<sub>2</sub> both reach the setpoint.

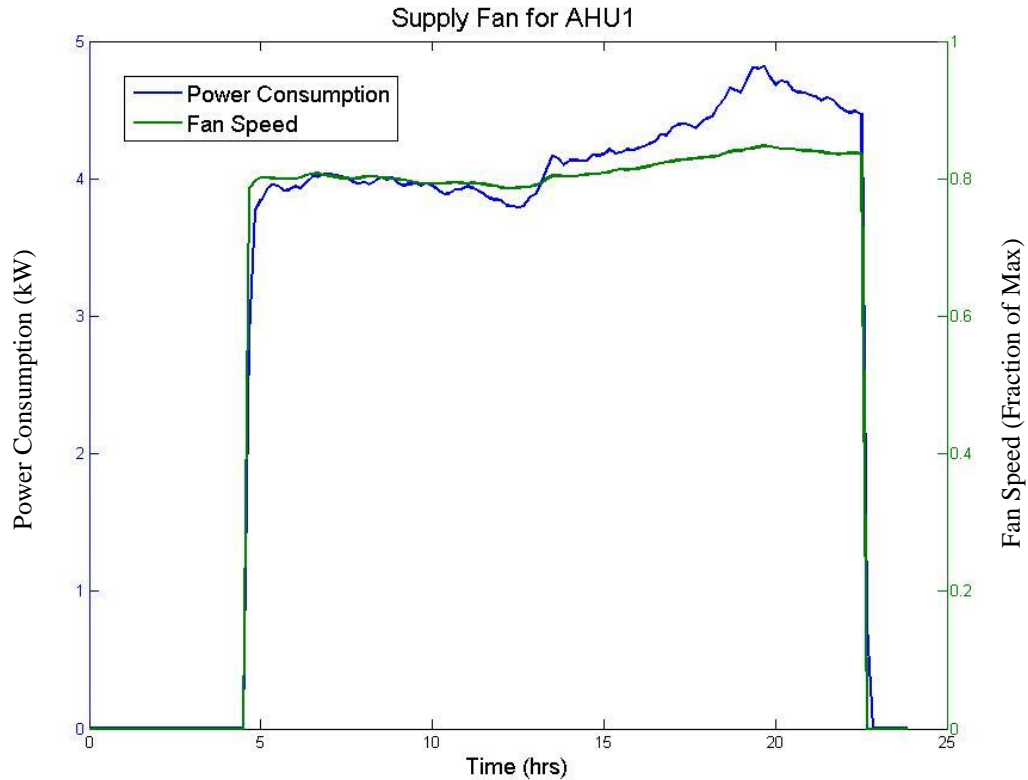
**FIGURE 25. POWER CONSUMPTION AND FAN SPEED FOR WEST DINING AHU 1 SUPPLY FAN**

Figure 25 below shows the power consumption for AHU 1 supply fan as well as its fan speed as a percentage of maximum frequency. Around 1:00 PM there is a slight rise in the fan speed. This corresponds to a much larger rise in the power consumption of the fan, and this disparity continues to rise as fan speed increases throughout dinner. This suggests that the optimum fan speed would remain below this value of about 0.825 as a fraction of maximum capacity. Once the fan speed reaches this point, the control system should modulate the hot and chilled water dampers in order to maintain the room temperature setpoint. To get a bit more insight into this problem, the team examined the room temperature and CO<sub>2</sub> for this data.

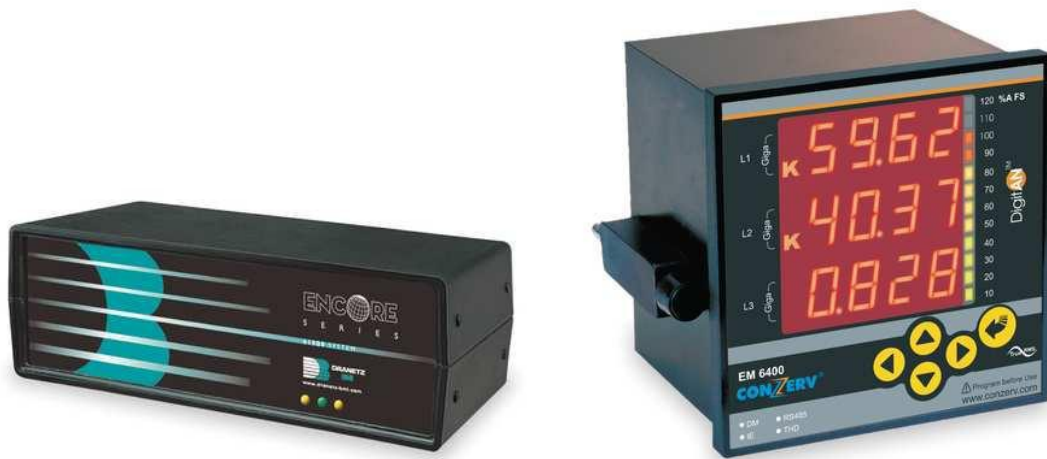
**FIGURE 27. DRANETZ ENCORE ENC-TR-S (LEFT) AND CONZERV EM6436 (RIGHT)**

DRANETZ ENCORE ENC-TR-S	CONZERV EM6436
Price	\$8,000	\$350
Input Voltage	1 to 600 VAC	80 to 600 VAC
Current Range	0 to 6,000 A	50 mA to 6 A
