10 DEEP RETROFIT CASE STUDIES

lain Walker – Lawrence Berkeley National Lab

Defining Deep Energy Retrofit (DER)

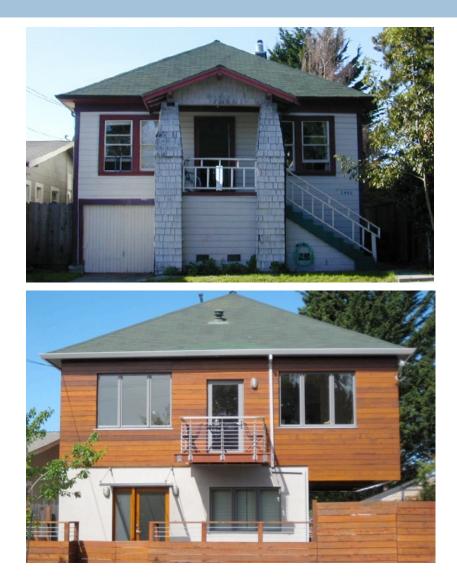
P1 Project Description

1904 Craftsman Bungalow Berkeley, CA

$Pre: 960ft^2 \implies Post: 1,630ft^2$

- Original home no insulation,
 1 natural gas floor heater on the 2nd level
- House raised, & the ground floor rebuilt to legal height
- Project guided by European Passive House principles
- 4 bedrooms, 2 baths, 4 occupants, home office

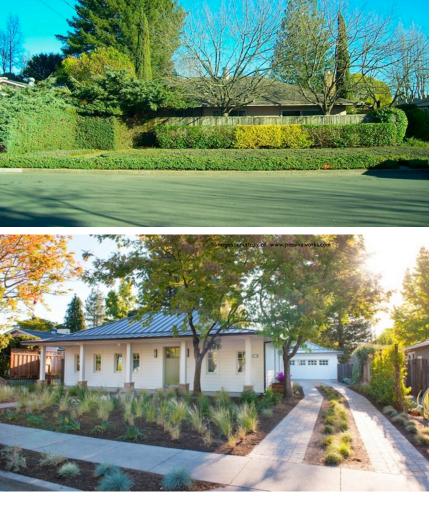
P3 Project Description

Two 1958 ranch-style homes connected by a covered breezeway Pre: 1,933 ft² Post: 2,342

The two structures were connected by forming a u-shaped home with a central courtyard

3 bedrooms, 2
 baths, 1
 occupant, home
 office

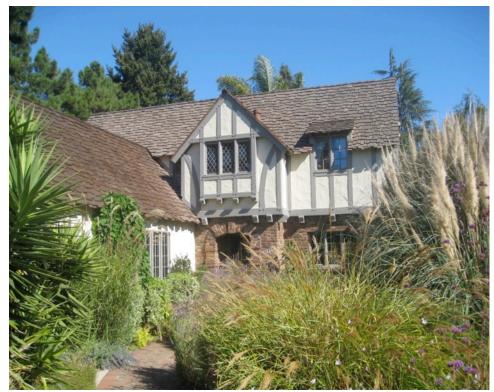
P2 Project Description

- 1936 English Tudor Revival-Style Home Palo Alto, CA Pre: 2,780 ft² → Post: 2,780 ft²
- Due to architectural significance, efforts made to maintain historical character throughout project
- 5 bedrooms, 3 baths, variable occupancy, home office

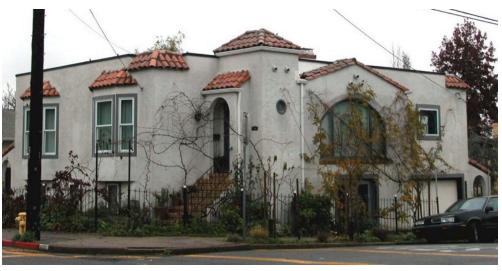
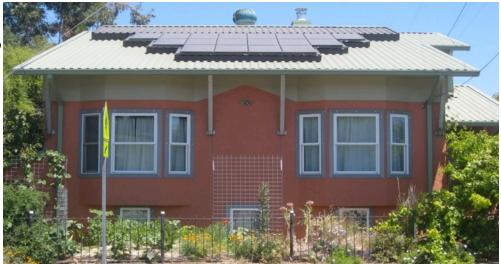
3-phase retrofit

- 1 1998 prior to moving in
- 2 2004 added renewable energy
- 3 2010 a structural/seismic retrofit
- Phase 4 Planning to reach net-zero carbon
- 1 st home to officially meet THC in CA!
- 2 bedrooms, 2 baths, 2 occupants, home office

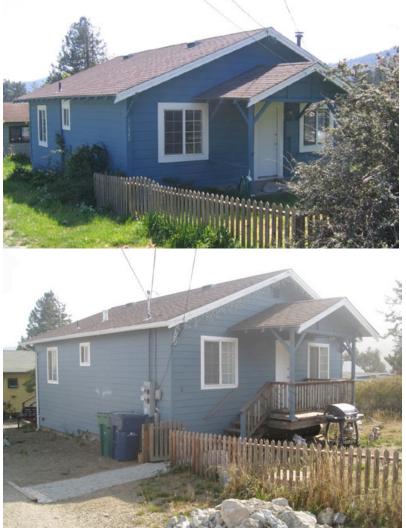
- 16
- 1920's 2-bedroom house Pt. Reyes Station, CA Pre: 800 ft² → Post: 905 ft²
- Community Land Trust Association of West Marin (CLAM) bought the property & funded the retrofit to rent to "very lowincome households"
- 2 bedrooms, 1 bath, 3 occupants

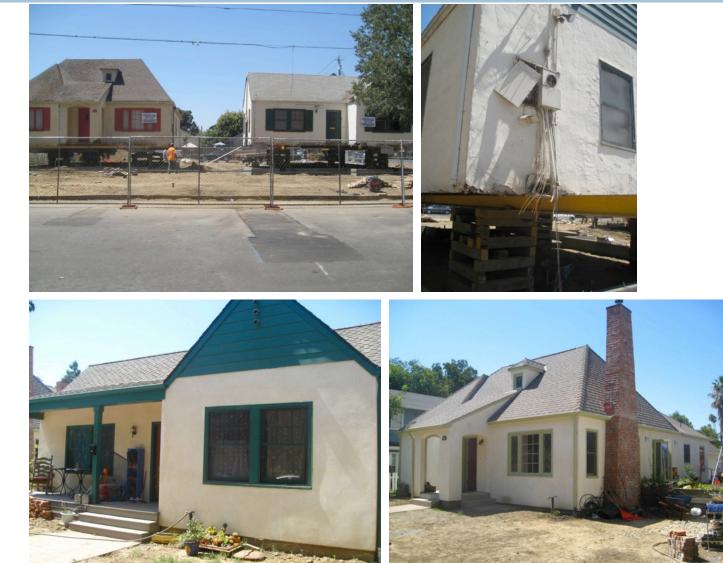
•2x stud wall homes with solar thermal are occupied by members of local co-housing association.

North-5 bedroom, 1 bathroom, 5 occupants
South-3 bedroom, 1 bathroom, 3 occupants

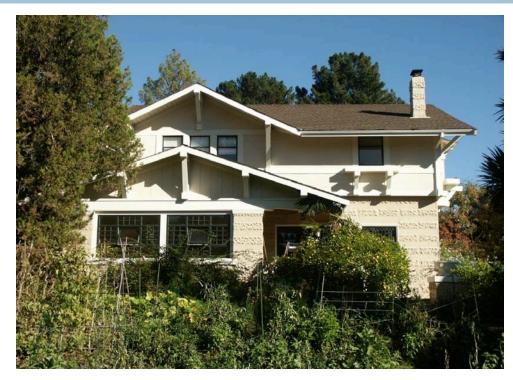
$\mathsf{Pre: 3136ft^2} \longrightarrow \mathsf{Post: 3288ft^2}$

- House within a house concept, using kitchen and rear zone as primary living space in winter. Insulated entire home, maintaining architecturally significant interiors, increased comfort and hope to achieve 1000 home challenge with future PV installation.
- 3 bedroom, 2.5 bath, 2
 Occupants

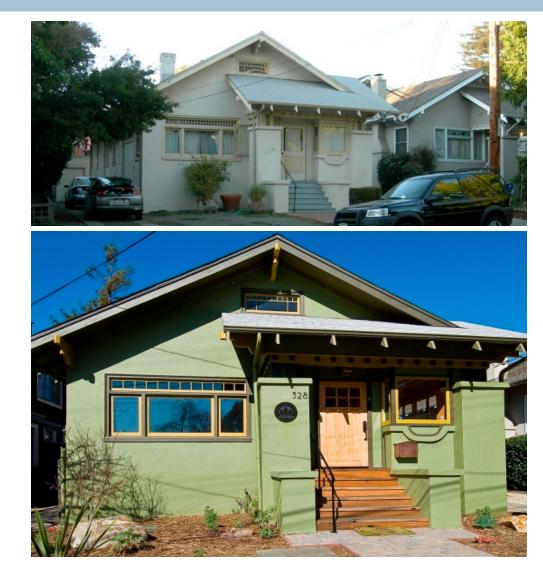
1915 Craftsman Bungalow Oakland, CA Pre: 1440ft² → Post: 1440ft²

- Super Green Retrofit– LEED Platinum rated, greywater, rainwater, sustainable materials and landscaping, low flow fixtures + energy efficiency
- 3 bedroom, 1.5 bath, 4
 Occupants

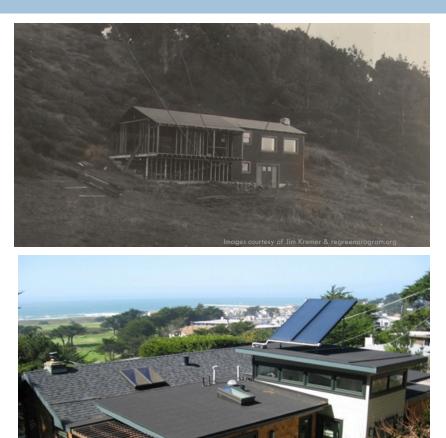
1938 Cottage Pacifica, CA Pre: 1,440 ft² → Post: 1,745 ft²

- Family-built "Shamrock Shack" remodeled for retirement with goals of resource & energy efficiency, while maintaining original charm with modern comforts
- 2 bedrooms, 1.5 baths, 2 occupants

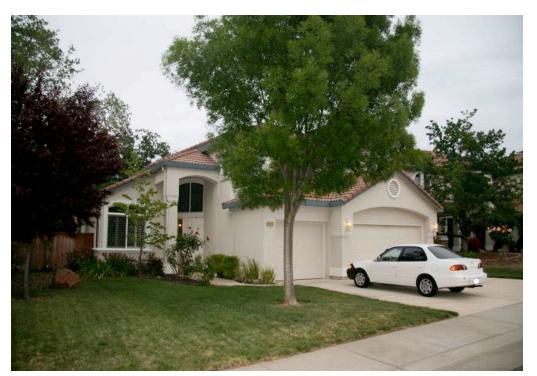
1998 Tract Home Folsom, CA Pre: 2,850 ft² → Post: 2,850 ft²

- SMUD Advantage home with a significant energy upgrade & a kitchen remodel
- Increased insulation, air sealed, lighting retrofit & an extensive HVAC overhaul
- 3 bedrooms, 2.5 baths, 4 occupants

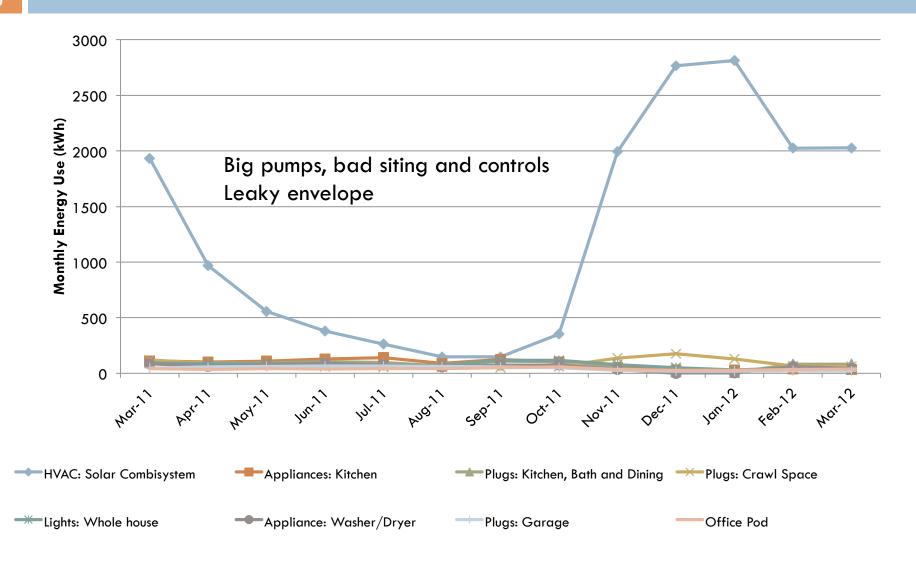
Not Fixing Problems with complex

systems

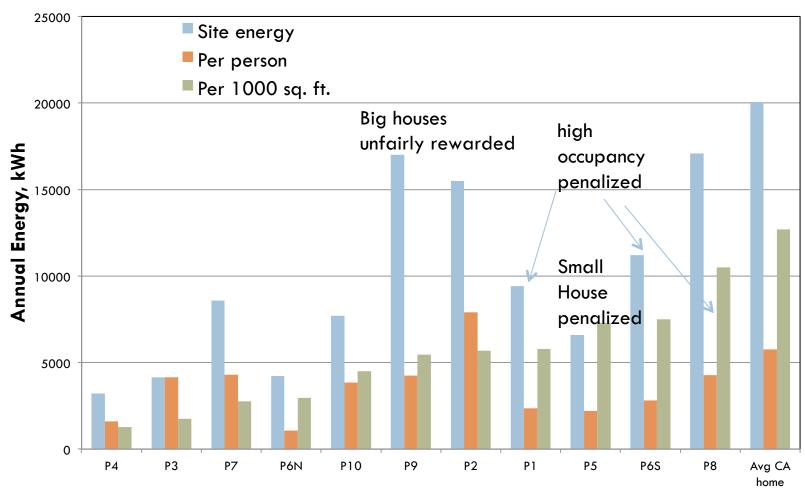
Normalization Metric Selection

Houses ordered by energy use per 1000 sq.ft
